## **Rutting Performance of Cold-Applied Asphalt Repair Materials for Airfield Pavements**

Final report

Under Project 448464; Airfield Damage Repair (ADR) Modernization Program

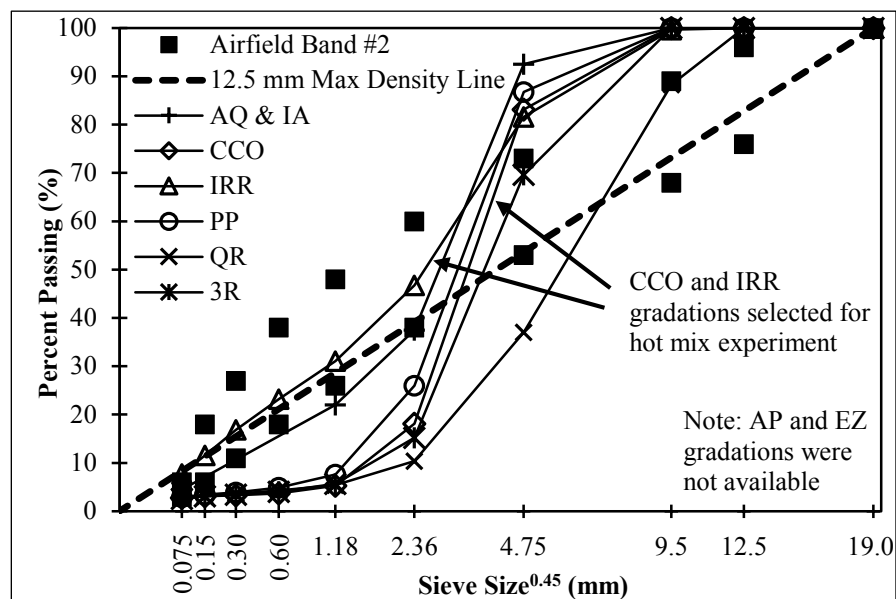
Figure 2.1. Cold mix asphalt gradations.

The maximum density line for a 12.5 mm nominal maximum aggregate size (NMAS) gradation is shown in Figure 2.1 since 12.5 mm is the largest NMAS tested. Individual plots for 4.75, 9.5, and 12.5 mm NMAS gradations were omitted for brevity as Figure 2.1 provides a depiction of each gradation for comparison. Most cold mixes are gap-graded and predominantly fall on the

coarse side of their corresponding maximum density line. IRR, plotting mostly along the 9.5 mm NMAAS max density line, was the key exception to this trend. Two 9.5 mm NMAAS gradations, CCO and IRR, were selected for later evaluation in a hot mix asphalt experiment. IRR was selected because it was a finer gradation, while CCO was selected because it was representative of the gapped gradations.

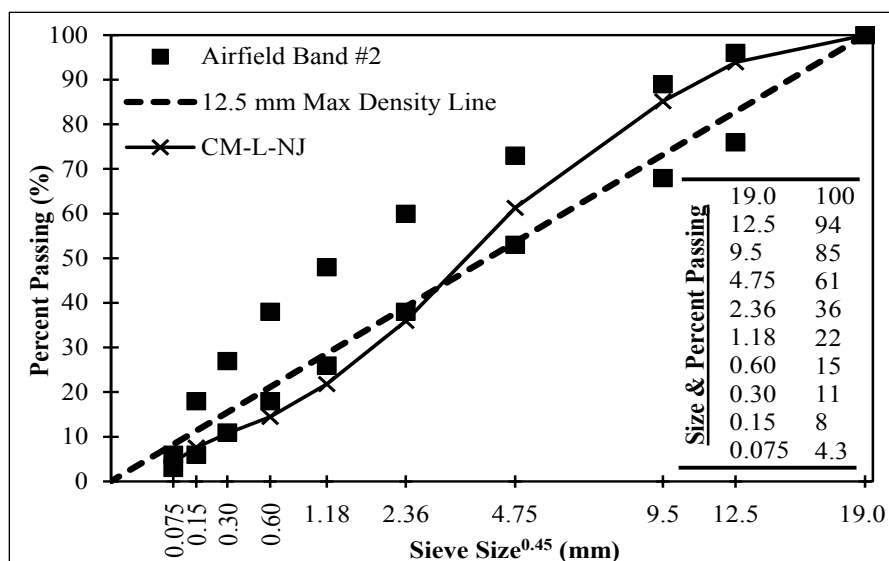
Figure 2.2. CM-L-NJ gradation.

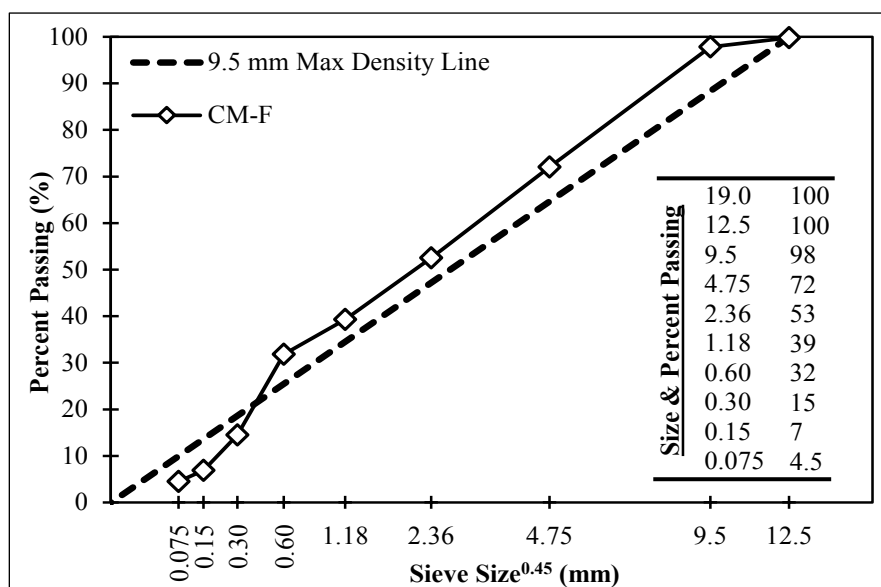
CM-F was a plant-produced, field-compacted warm mix asphalt (WMA) with 25% reclaimed asphalt pavement (RAP) provided by the APAC Mississippi plant in Vicksburg. It was used in this study as a control for cold mixes during the field component of this study and was treated as a hot mix, rather than warm mix, asphalt during this study, meaning it was heated to approximately 300 °F during testing. Detailed laboratory characterization of the CM-F sample was not conducted; limited properties were available from the supplier. Design  $P_b$  was 6.0% using a PG67-22 binder; specific gravities and volumetrics were not provided. Figure 2.3 provides the design CM-F gradation which was a 9.5 mm NMAS.

Figure 2.3. CM-F gradation.

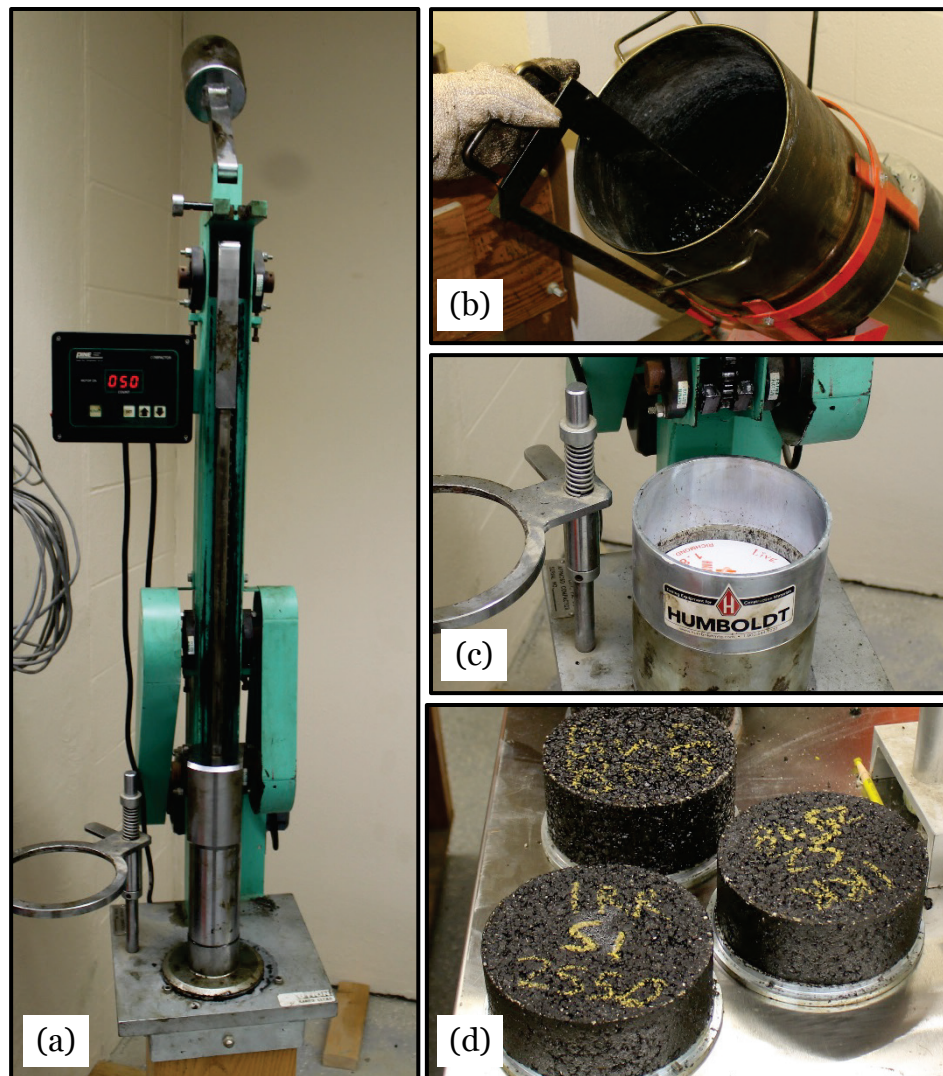
Figure 2.4. Photographs of laboratory mixing and compaction: (a) automatic Marshall compactor, (b) HMA bucket mixer, (c) Marshall mold filled with mix, (d) specimens on lab bench.

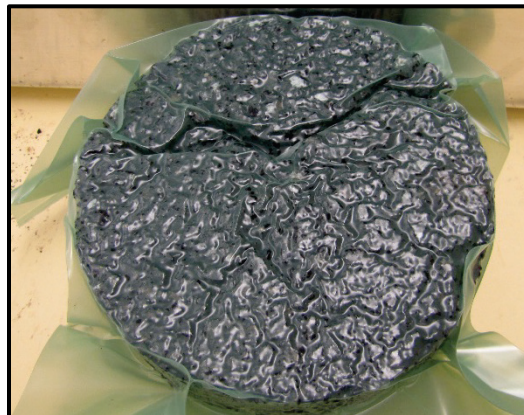
$G_{mb}$ , using the CoreLok® device, was measured on specimens for which  $G_{mm}$  was also measured. Cold mix specimens, in particular, were measured for  $G_{mb}$  after either one day of curing or on the final day of their curing protocol (e.g., at 5 days). Difficulties in vacuum sealing were sometimes encountered with cold mix specimens because the mixtures were relatively soft and easily deformed by the CoreLok bag as it sealed around a specimen (Figure 2.5). Care was taken to alleviate this problem to the extent possible by aligning the bag and specimen such that folds in the bag were less likely to occur.

Figure 2.5. Typical cold mix specimen deformed by CoreLok bag.

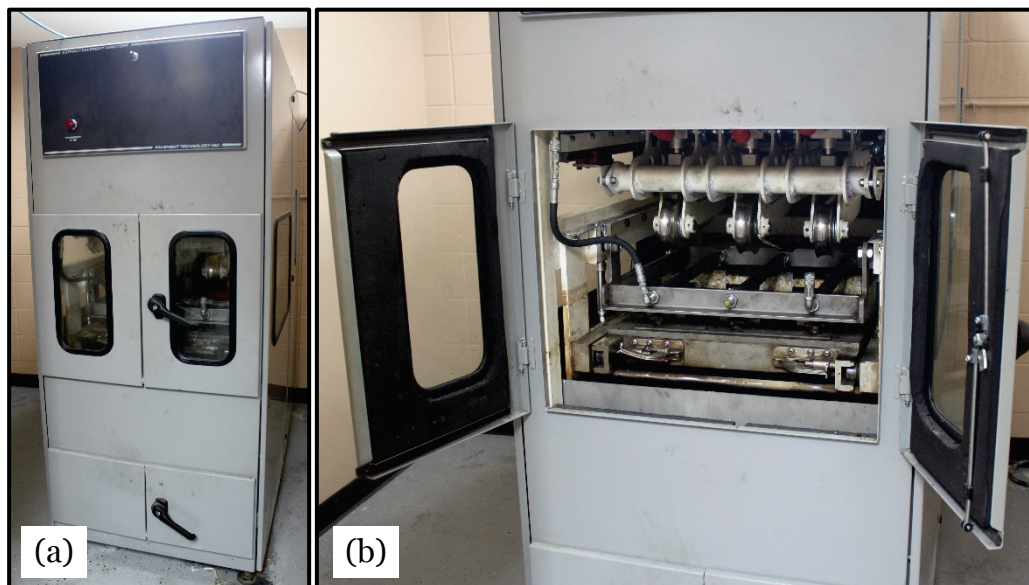
Figure 2.6. Asphalt pavement analyzer: (a) overall, (b) inside of cabin.

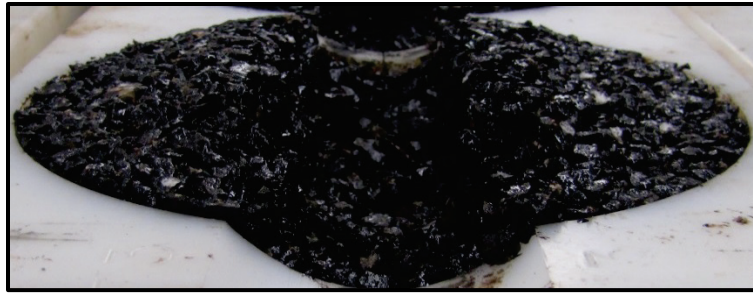
Figure 2.7 provides a typical photograph of a tested APA specimen in an APA mold. A type of screening process was used when determining the APA test plan. All cold mixes were tested after one day of curing. For 3-day and 5-day APA testing, only select mixes were tested based on both 1-day APA results and a more subjective assessment after handling the mixtures in the laboratory, as discussed in the laboratory results chapter.

Figure 2.7. Typical tested APA specimen.

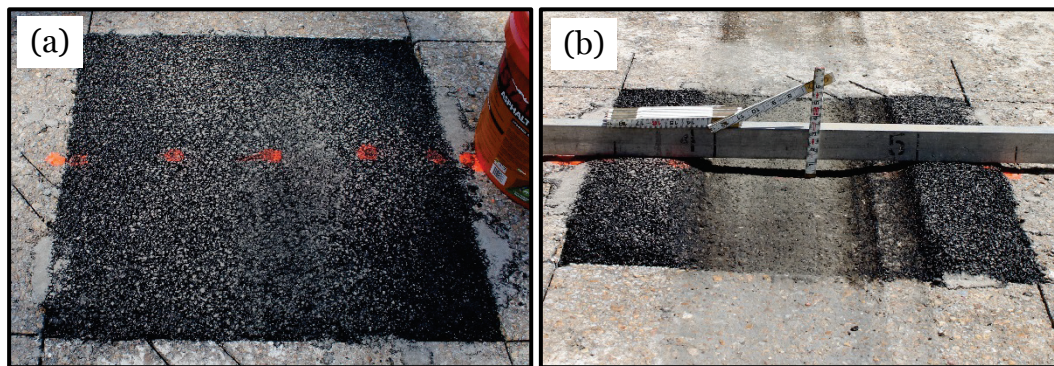
Patches were placed with hand tools in two approximately equal lifts of material. For the water-activated cold mixes, AQ and IA, water was added according to manufacturer recommendations. Cold mix compaction was achieved via a hand tamp and a Northern Industrial Equipment JPC-80 vibratory plate compactor (PC). HMA compaction was achieved via a CAT walk-behind steel wheel roller (CR). Figure 2.8a shows an example of a compacted field patch. In-place densities were not obtained.

Figure 2.8. Example field patch (IA shown): (a) before trafficking, (b) after trafficking.

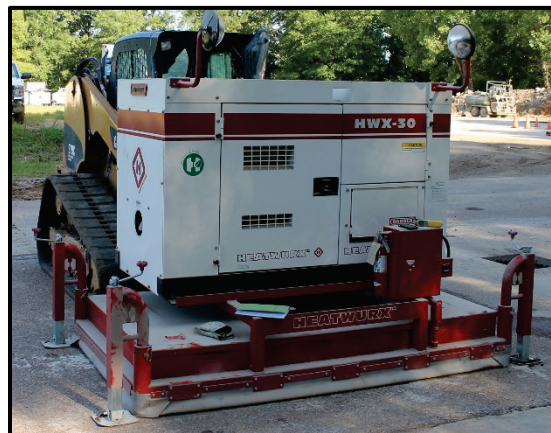
Heatwux HWX-30 heater (Figure 2.9) was outfitted with a thermostat to maintain a relatively constant temperature of 375 °F. Infrared heating increased patch surface temperatures to approximately 155 °F after 20 min. Infrared heat was applied to the first patch beginning immediately after compaction so that the fourth patch had time to cool to approximately ambient pavement temperatures. Condition 3 utilized a 72-hr ambient-temperature cure time.

Figure 2.9. Heatwux infrared heater.

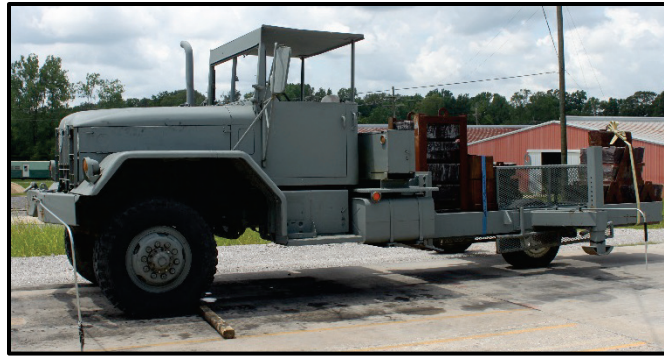
Trafficking was conducted with a load cart outfitted with an F-15E tire as shown in Figure 2.10. The load cart was designed to simulate the maximum single-wheel F-15E gross loading of 35,235 lb at a tire pressure of 325 psi. A channelized traffic pattern was used in this project. During trafficking, deterioration of the repair was monitored, and rutting measurements were recorded periodically based on the rate of deterioration. Rut measurements were taken as shown in Figure 2.8b by placing a straightedge across the rut and measuring the maximum rut depth. Trafficking was conducted to either failure, which was established as 1 in. (25.4 mm) of rutting, or 100 passes.

Figure 2.10. F-15E load cart.

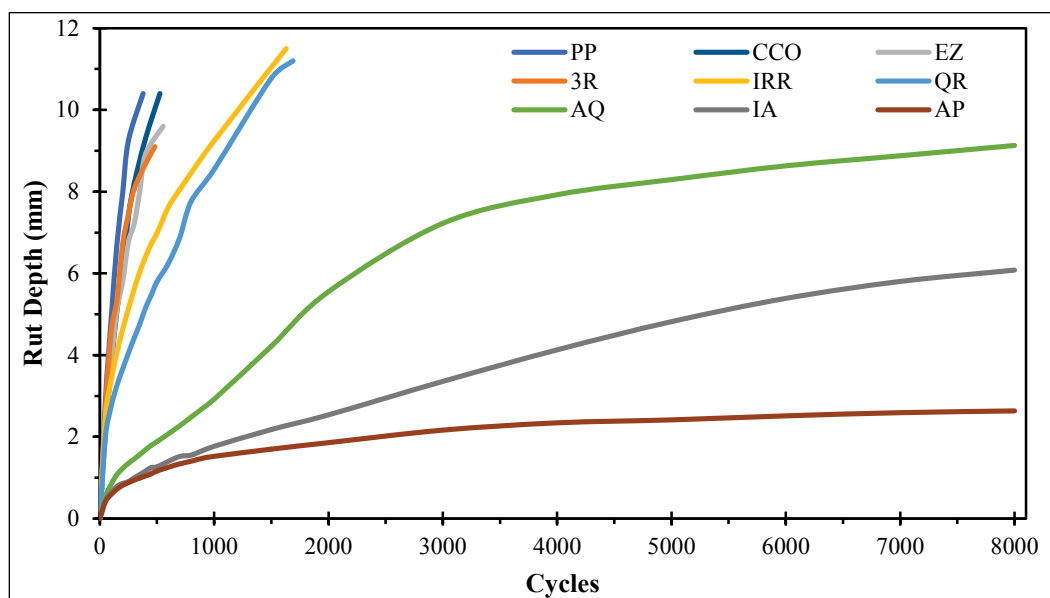
that lasted 8,000 cycles. These two categories are further referred to as Group B and Group A products, respectively. Recall that APA testing in this report was conducted at 43 °C rather than the traditional 64 °C test temperature. Behaviors of these materials would likely worsen at 64 °C; this should be considered when discussing results (e.g., a 6 mm rut depth at 8,000 cycles and 43 °C would be greater with respect to standard 64 °C testing).

Figure 3.1. Cold mix 1-day APA results.

From a material selection perspective where rutting is the primary point of interest, there is little motivation to recommend a product failing at less than 2,000 cycles (Group B) for anything other than extreme emergency situations when there are products that exhibit significantly better rut characteristics (Group A). In normal operations, the group of products including AQ, IA, and AP would be preferred. It is of interest to note that IRR, the currently used cold mix material, is located in the less desirable group, suggesting that revisions to approved-product lists may be worth considering.

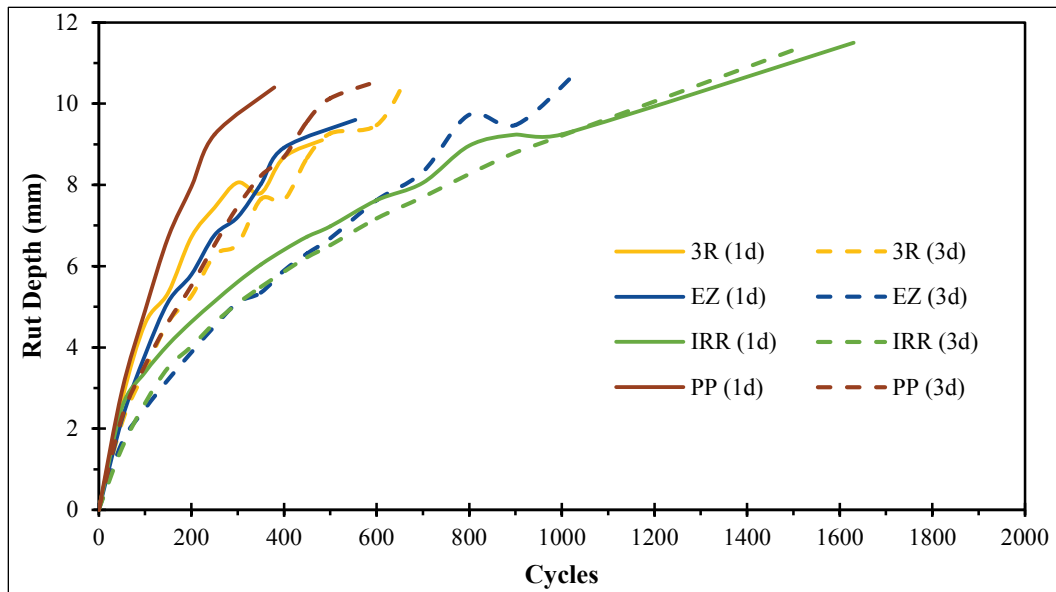
Figure 3.2. Cold mix 1 and 3 day APA results.

Figure 3.2 plots rut data to 2,000 cycles and illustrates that additional curing time did not meaningfully improve rutting characteristics for any of the Group B products. EZ's cycles to failure approximately doubled between 1 and 3 days of curing; however, increasing from 500 to 1,000 cycles is not meaningful considering the product, even at 3 days, only withstood one-eighth of a standard APA test at a reduced temperature. Other improvements with curing time were less noticeable than that of EZ or effectively nonexistent.

While early rutting performance is often of primary interest for airfield applications, understanding material behavior over time as the cold mixes cure is beneficial. Figure 3.2 presents 3-day results for comparison to 1-day results for select Group B cold mixes. Figure 3.3 presents 1-, 3-, and 5-day results for Group A cold mixes as well as IRR for comparison since IRR is the current recommended product.

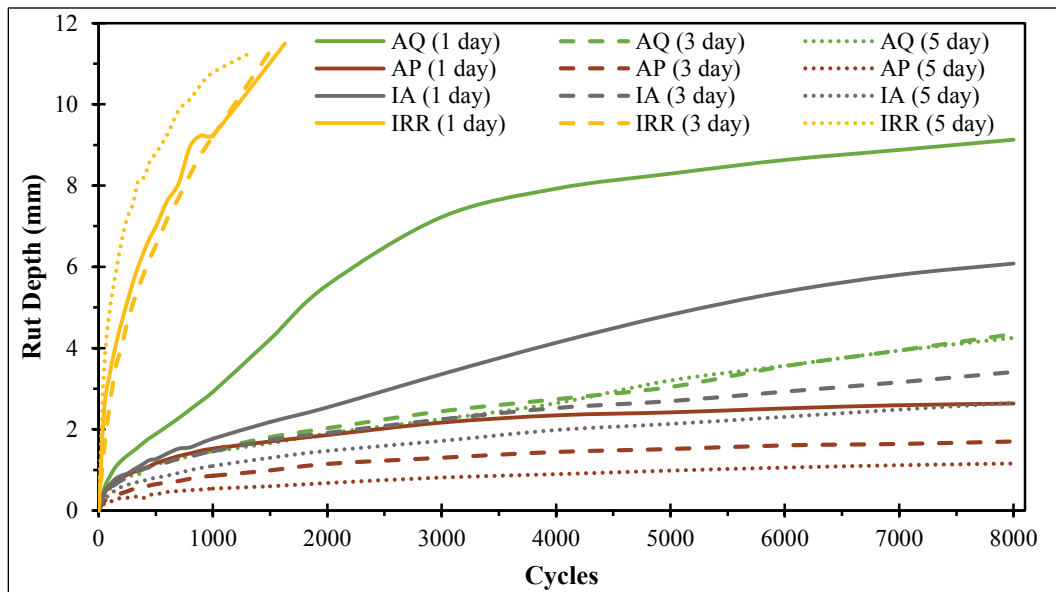
Figure 3.3. Cold mix 1, 3, and 5 day APA results.

Figure 3.3 demonstrates that additional curing time could have moderate effects on Group A products. IRR results were included for completeness. As with Figure 3.2, IRR 5-day results were not improved relative to 1- or 3-day results and were likely within the variability of the material and test.

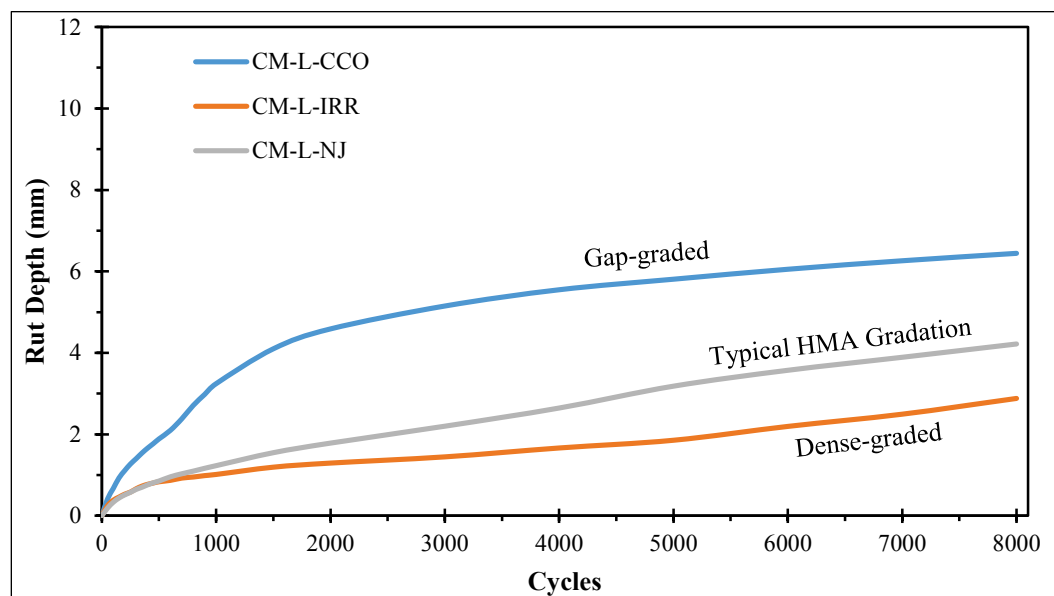
Figure 3.4 provides APA results for the HMA control mixtures. The most informative result in terms of comparison with cold mixes is that of the fully-designed CM-L-NJ mixture. Its rut depth is approximately 4 mm, and it assists in further assessing performance within Group A mixtures. From Figure 3.3 Group A mixtures, only AQ and IA 1-day results exceeded 4 mm; all others exhibited rut depths of approximately 4 mm or less.

Figure 3.4. HMA control mixture APA results.

CM-L-CCO and CM-L-IRR results were presented to examine the effect of gradation on rutting performance with the intent of better understanding the performance of Group B products. Gradation can affect the overall stability of a mixture and its subsequent resistance to rutting. However,

because of the potential issues with the laboratory-fabricated control mixtures, APA results of CM-L-CCO and CM-L-IRR should be considered questionable as actual  $V_a$  values in addition to specimen integrity are not truly known for these mixtures.

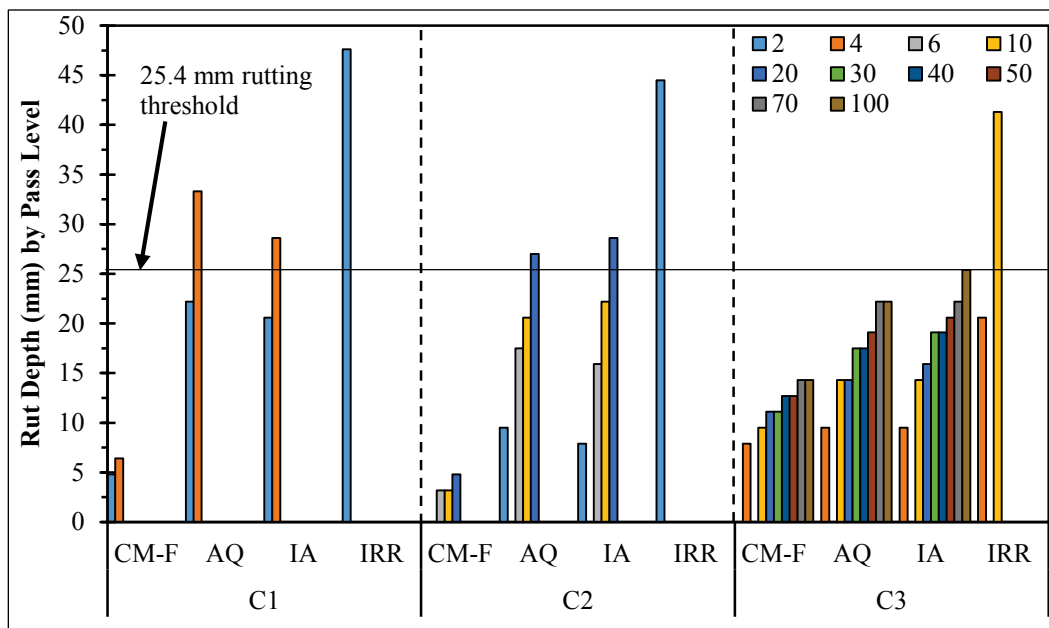
Figure 4.1 presents rutting results measured using a straightedge during Phase 1 field testing. Cold mix patches were generally arranged within the test grid pattern in order from best to worst rutting expectations based on laboratory results. This was done so that if the worst cold mix failed (reached 25.4 mm rut depth), trafficking of the remaining patches could continue unimpeded. If all cold mixes failed prior to reaching 100 passes, trafficking of CM-F was also stopped.

Figure 4.1. Phase 1 field rutting results by pass level.

For C1 (2 hr ambient curing), the currently recommended product IRR failed within just two passes of the load cart. Note that the rut depth after two passes was nearly double the failure threshold. AQ and IA performed similarly, but both failed after only four passes. Their performance was drastically different than that of CM-F, which was placed as a hot mixture.

For C2 (1 hr 40 min ambient curing with 20 min infrared heating), IRR again failed within two passes; its rut depth improved very slightly, but not meaningfully, relative to C1. AQ and IA again performed fairly similarly, failing within 20 passes. Performance increased by a factor of five relative

to C1; however, the number of passes to failure was still relatively low. By contrast, CM-F rut depths were less than 5 mm and were also lower than in C1. Recall that CM-F was not conditioned with infrared heating in C2 like cold mixes; therefore, CM-F conditions were identical between C1 and C2. The slight differences in rut depth between C1 and C2 could be a result of in-place density differences from one patch to another or an increased pavement temperature at the time of C2 testing.

For C3 (72 hr ambient curing), IRR failed within 10 passes, which, while slightly better than performance in C1 or C2, was not a practically meaningful increase. AQ and IA performed closely and withstood 100 passes, meeting the objective pass level. Rut depths were greater with CM-F relative to C1 and C2, perhaps partly due to lower densities or an increased pavement temperature at testing relative to C1, and would not have necessarily benefited from the additional curing time since HMA, unlike cold mixes, would be almost unaffected by ambient conditioning times in the 2 to 72 hr range.

Overall, the beneficial effect of additional curing time on cold mixes, especially AQ and IA, is evident from Figure 4.1. AQ and IA outperformed IRR, particularly after a longer curing time. AQ and IA demonstrate a better curing efficiency in that the increase in rutting resistance with curing time is significantly greater than for IRR. While AQ rutted slightly less than IA after C3 conditioning and 100 passes, this difference is of little significance without additional replication.

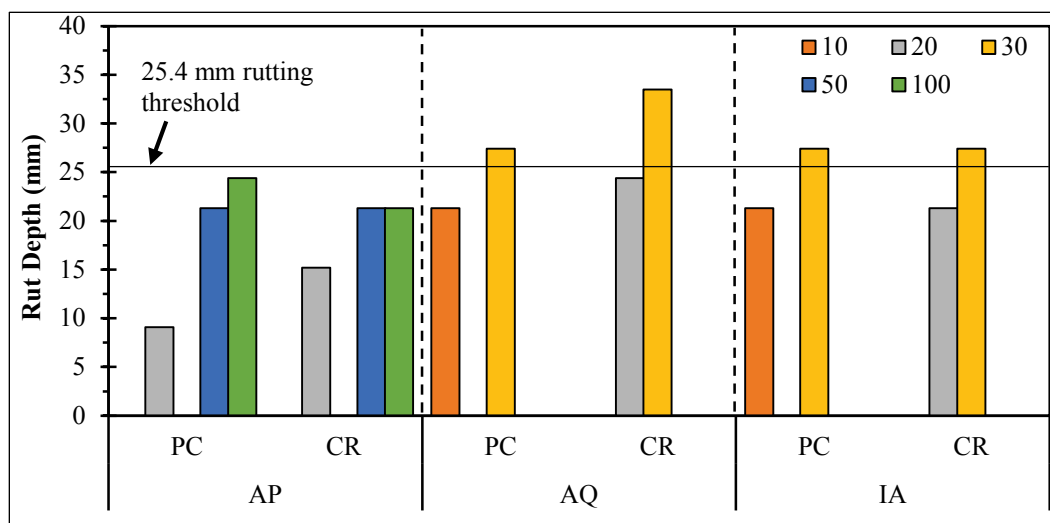
Figure 4.2 presents rutting results measured using a straightedge during Phase 2 field testing. Phase 2 differed from Phase 1 in that CM-F was not tested again but AP was tested. Additionally, only one curing condition (C4) while two compaction methods (PC and CR) were considered.

As in Phase 1 field testing, AQ and IA performed similarly. Both failed within 30 passes for both PC and CR compaction. However, AP did not exceed the 25.4 mm rutting threshold after 100 passes. AP rutting behaviors were also similar for both PC and CR compaction. Overall, AP performed considerably better than AQ and IA with respect to rutting resistance.

Figure 4.2. Phase 2 field rutting results by pass level.

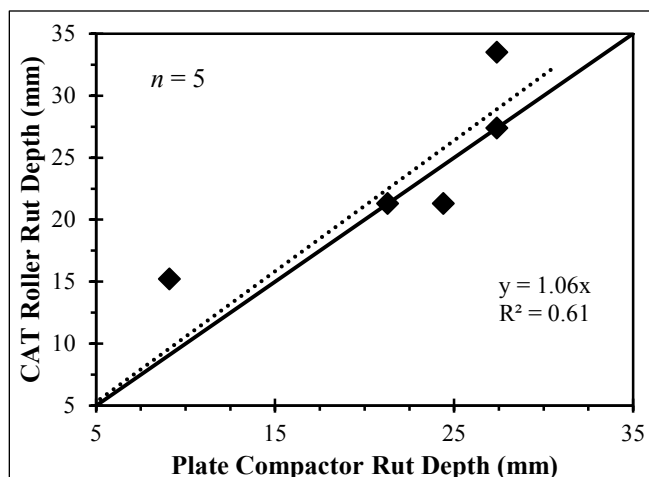
Figure 4.3 is an equality plot comparing CR and PC compaction methods where direct pairs of data were available (i.e., rut measurements for both PC and CR at the same pass level). Figure 4.3 was constructed using straight-edge rut measurements from Figure 4.2. In general, patches compacted with the CAT roller tended to yield higher rut depths than those compacted with the plate compactor. Considerable variability is present, however. Regression through the origin illustrates that, on average, a 25.4 mm rut depth for PC-compacted patches was equivalent to a 26.9 mm rut depth for CR-compacted patches. Given the limited and variable data available, this is not a meaningful finding. Overall, rutting resistance was not meaningfully impacted by one compaction method over another.

Figure 4.3. CR and PC comparison using straightedge rut measurements.

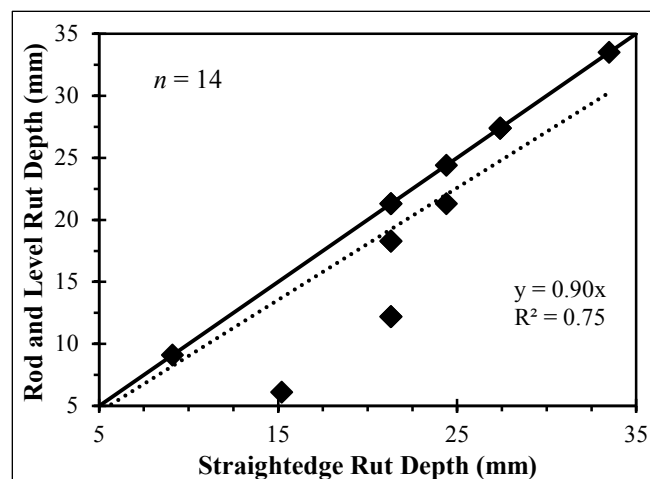
Figure 4.4 provides an equality plot comparing rut measurements obtained via surveys (rod and level) or a straightedge. Data points were either on the equality line or below it, indicating that survey and straightedge measurements were identical in some cases and, where they were not, straightedge measurements produced greater rut depths. Cases in which survey and straightedge measurements were not equal occurred when upheaval was present on either side of the wheel path. This increased the elevation of the straightedge relative to surrounding pavement since it was resting on this upheaved material when measurements were taken. Conversely, survey measurements used the surrounding pavement as the reference for rut measurements.

Figure 4.4. Comparison of survey and straightedge rut measurements.
